Environment, Climate Change and Low Carbon Economy Programme

European Economic Area (EEA) Financial Mechanism 2014-2021

A2 Report – Characterisation of waste

37_Call#2_Circular Construction in Energy-Efficient Modular Buildings

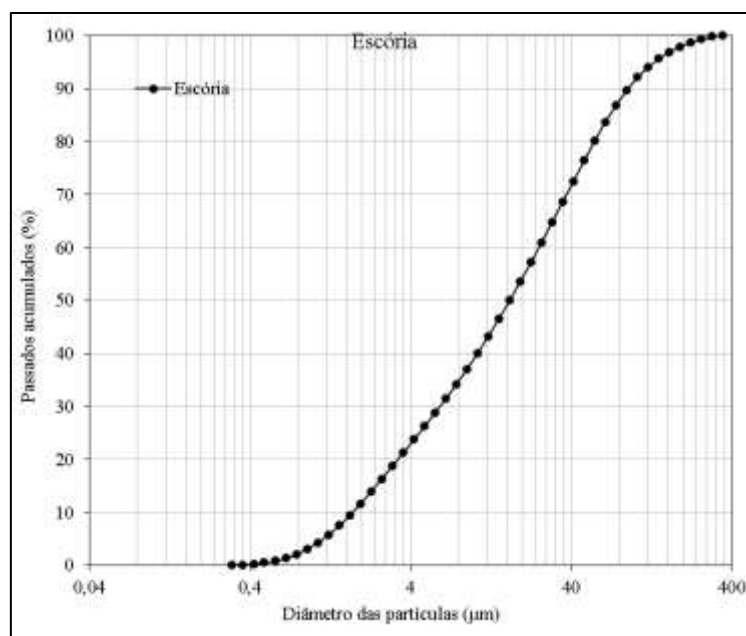
The slag, obtained from the LIPOR company, was provided with a granulometry smaller than 2,0mm, after hand-removal of bigger materials. Initial treatment was needed using the Los

Figure 4 – LIPOR slag granulometry

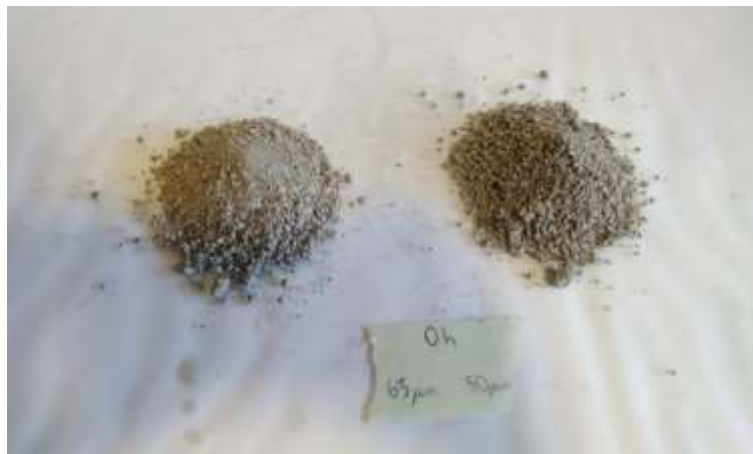
Figure 5 – Passing material at 0h

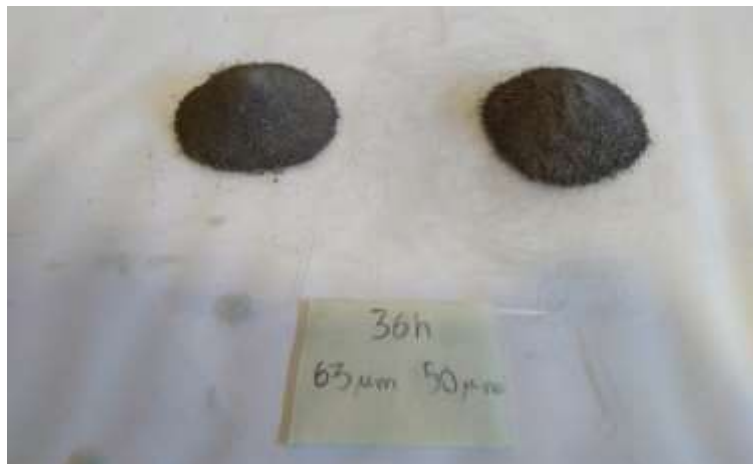
Figure 6 - Passing material after 36h

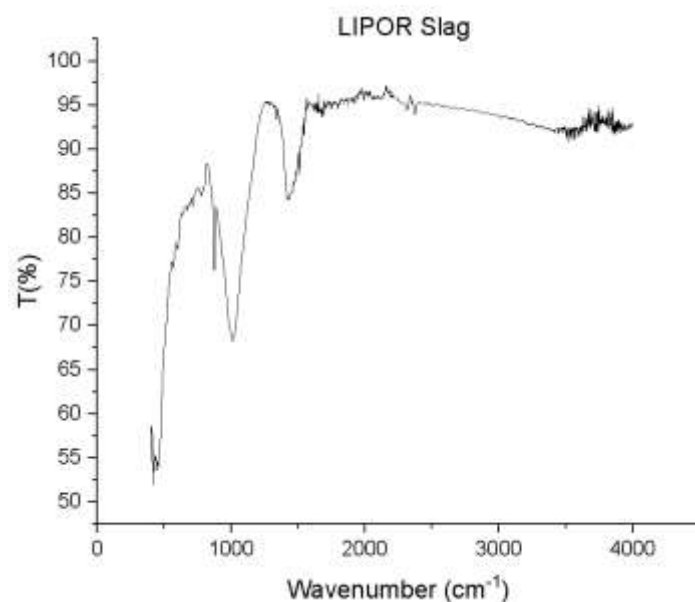
Figure 9 shows the results of FTIR analysis using a Shimadzu IRAffinity-1S equipment with wave range between 400 e 4000 cm^{-1} , resolution of 4 and 64 scans.

Figure 9 – FTIR analysis

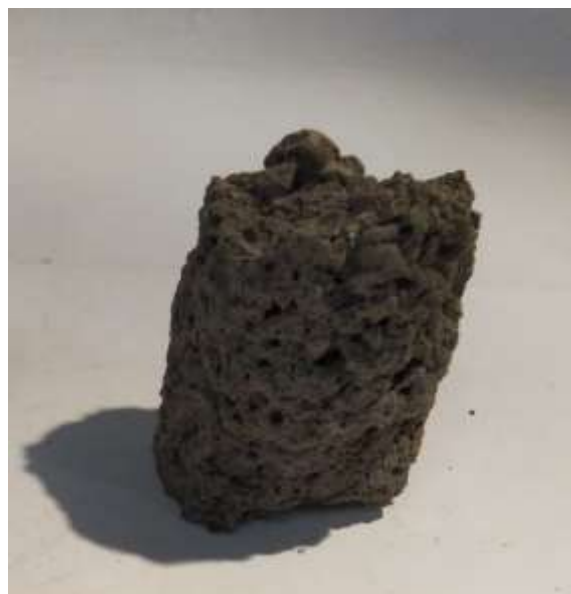
hydroxide with a molar concentration of 5. The curing process of the paste is presented in Table 5. As shown in Figure 10, the specimen couldn't be unmolded, since it wasn't strong enough. Therefore, there is no mechanical resistance results for this material.

Figure 10 - LIPOR slag specimen (after unmolding)

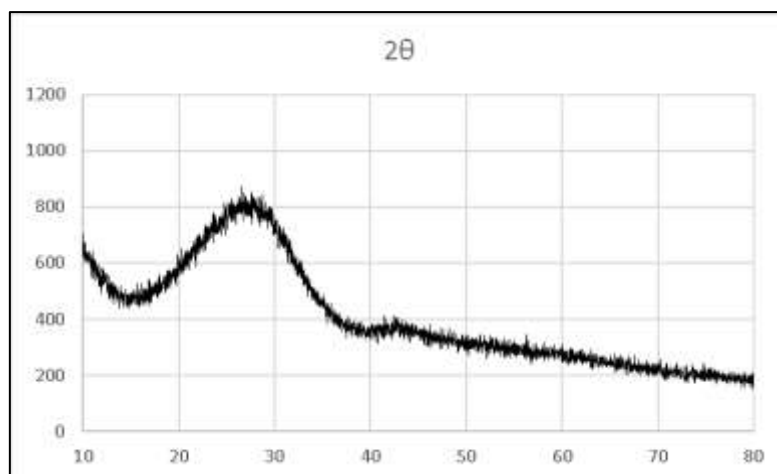
The diffraction pattern obtained from XRD is present in Figure 12. The composition was obtained using XRF and is presented in Table 7.

Figure 12 – XRD results

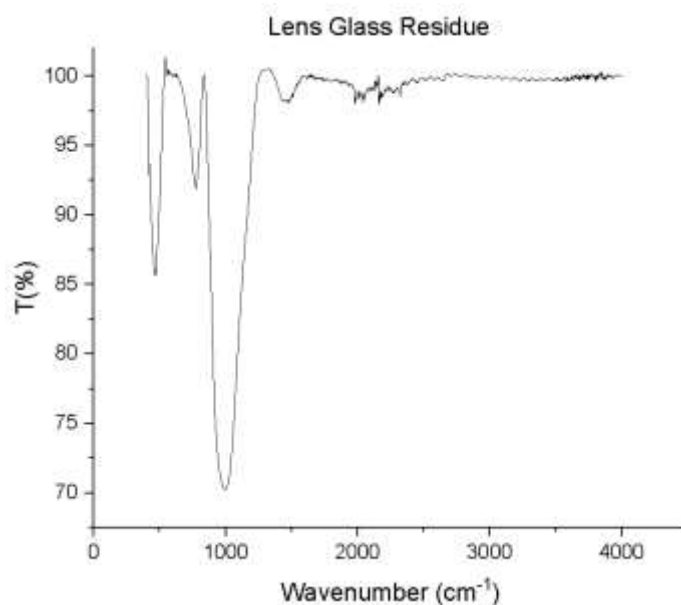
Figure 13 presents the FTIR analysis of the glass residue using a Shimadzu IRAffinity-1S equipment with a wave range between 400 e 4000 cm⁻¹, resolution of 4 and 64 scans.

Figure 13 – FTIR results

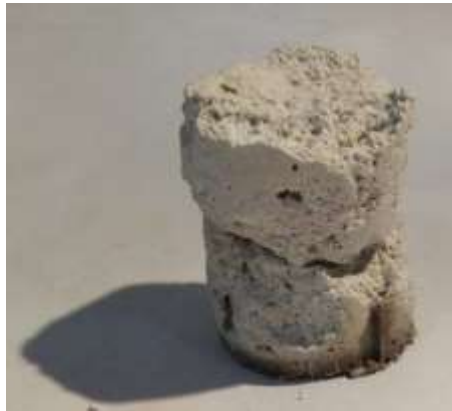
A single cylindrical specimen was produced to assess the mechanical resistance of the material. The quantity of material used for the paste is presented in Table 8. The activator used was hydroxide with a molar concentration of 5. The curing process of the paste is presented in Table 9. As shown in Figure 14, the specimen couldn't be unmolded, since it wasn't strong enough. Therefore, there is no mechanical resistance results for this material.

Figure 14 – Lens glass residue specimen (after unmolding)

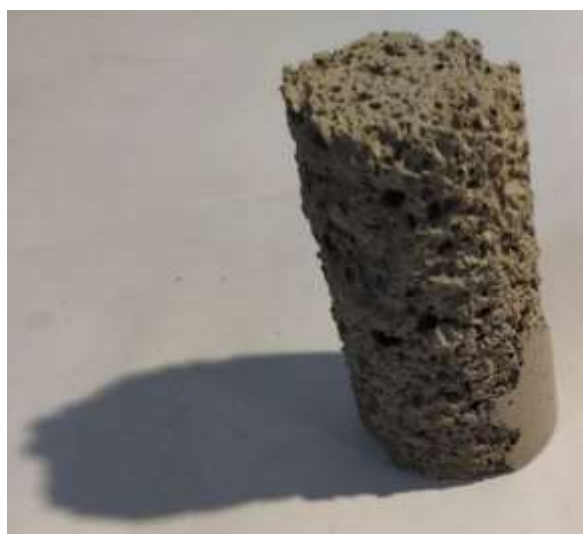
A single cylindrical specimen was produced to assess the mechanical resistance of the material. The quantity of material used for the paste is presented in Table 12. The activator used was hydroxide with a molar concentration of 5. The curing process of the paste is presented in Table 13. The specimen was successfully unmolded, has shown in Figure 18, and the mechanical results are presented in Table 14.

Figure 18 – BAGLASS glass residue specimen (after unmolding)

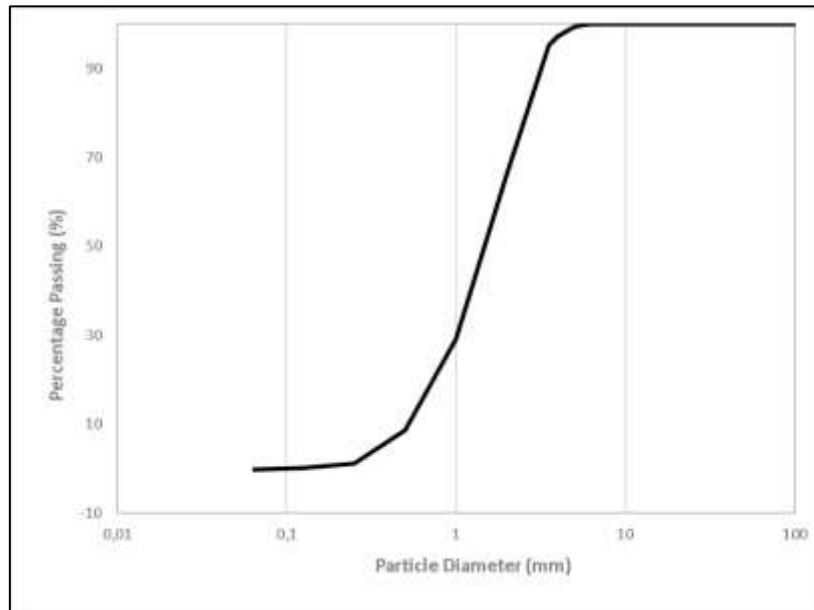
The granulometry of the residue is presented in Figure 19, obtained through laser, with resolution between 0,9µm and 175µm.

Figure 19 - Ceramic residue granulometry

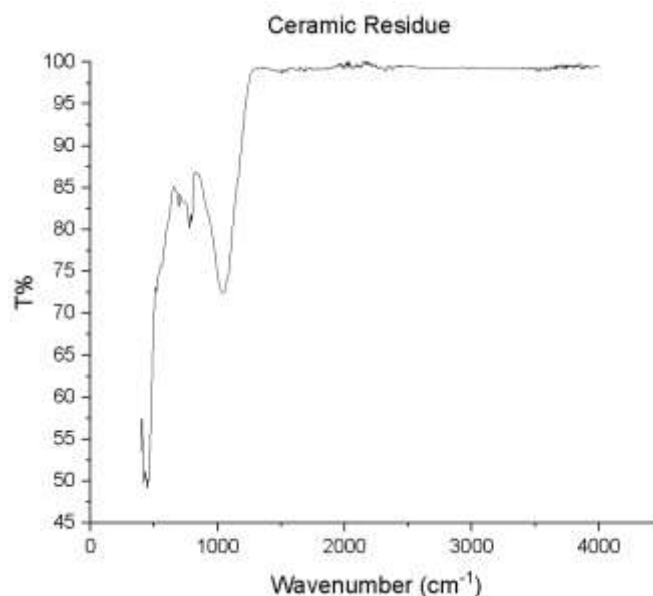
Figure 22 presents the FTIR analysis of the ceramic residue using a Shimadzu IRAffinity-1S equipment with wave range between 400 and 4000 cm^{-1} , resolution of 4 and 64 scans.

Figure 22 – FTIR analysis

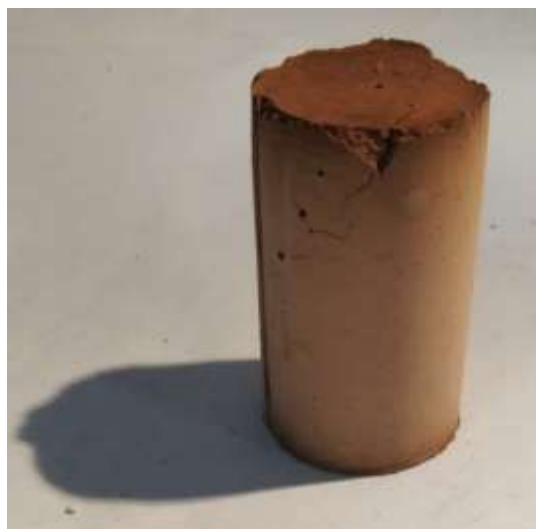
A single cylindrical specimen was produced to assess the mechanical resistance of the material. The quantity of material used for the paste is presented in Table 18. The activator used was hydroxide with a molar concentration of 5. The curing process of the paste is presented in Table 19. The specimen was successfully unmolded, has shown in Figure 23, and the mechanical results are presented in Table 20.

Figure 23 – Ceramic residue specimen (after unmolding)

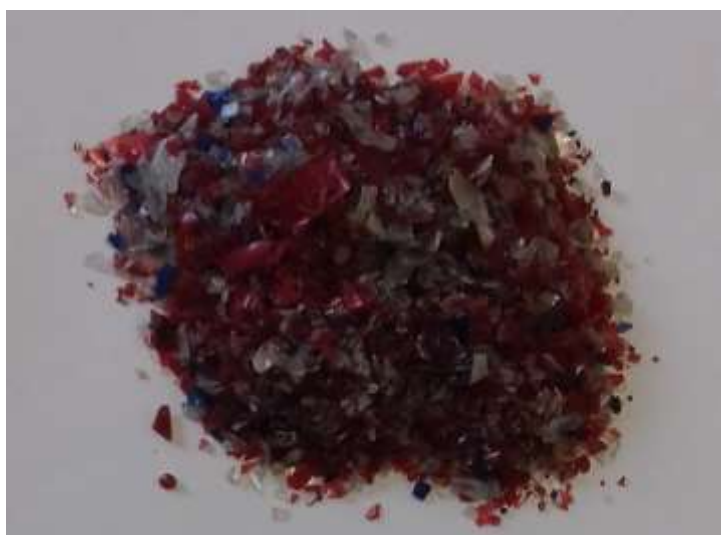
Figure 24 illustrates the plastic residue after milling. This waste was only submitted to microstructural analysis, namely scanning electron microscopy, x-ray diffraction and Infra-red Spectroscopy, since its physical properties were considered irrelevant, as its specific role in the final composites was unclear, at the start of the study, and it was important to know its chemical and mineralogical composition, so that a possible research plan including this waste could be drawn. There was also no viable way of producing a specimen that could be tested for compressive strength, or any other type of mechanical performance, given the specific properties of plastic and, in particular, of the physical format (angular particles, with a wide size range) that this waste possessed.

Figure 24 - Photography of plastic residue after milling.

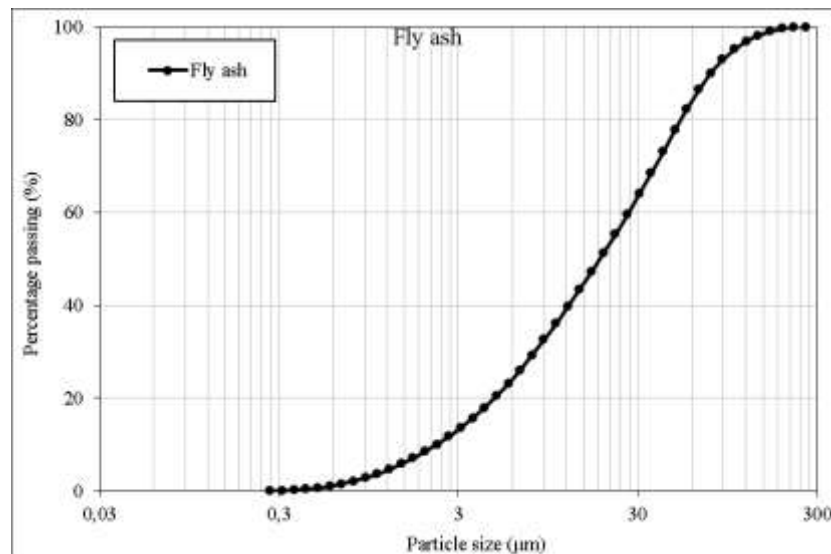
Figure 28 presents the granulometry of the fly ash.

Figure 28 - Granulometry of the fly ash

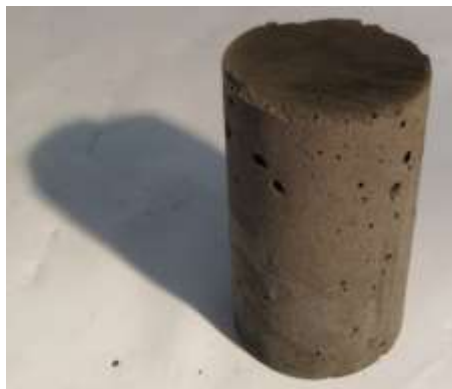
A single cylindrical specimen was produced to assess the mechanical resistance of the material. The quantity of material used for the paste is presented in Table 24. The activator used was hydroxide with a molar concentration of 5. The curing process of the paste is presented in Table 25. The specimen was successfully unmolded, has shown in Figure 31, and the mechanical results are presented in Table 26.

Figure 31 – Fly ash residue specimen (after unmolding)

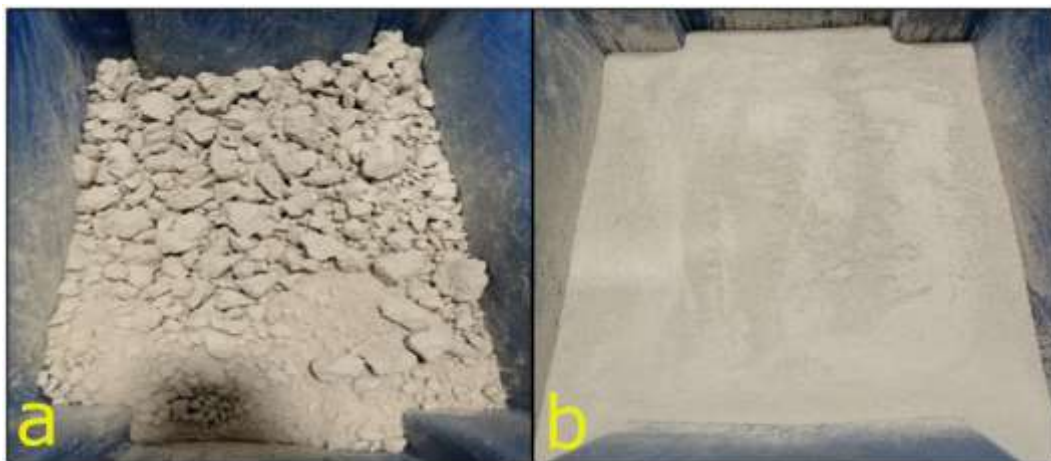
Given the state of the material on arrival, the residue was dried and sieved using 2,0mm and 500µm sieves. This process allowed the disaggregation of the bigger particles and the removal of small metal fragments from the marble cutting process. The result of the initial treatment is presented in Figure 32.

Figure 32 - Marble residue before (a) and after (b) sieving

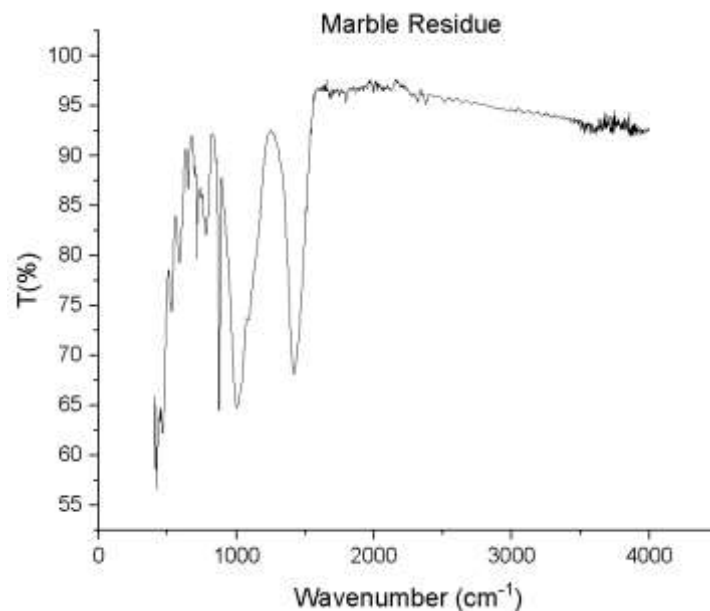
Figure 35 presents the results of FTIR analysis using a Shimadzu IRAffinity-1S equipment with wave range between 400 and 4000 cm^{-1} , resolution of 4 and 64 scans.

Figure 35 – FTIR analysis

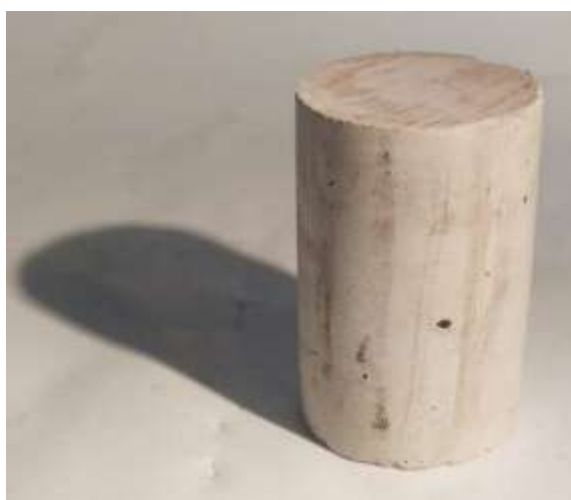
A single cylindrical specimen was produced to assess the mechanical resistance of the material. The quantity of material used for the paste is presented in Table 29. The activator used was hydroxide with a molar concentration of 5. The curing process of the paste is presented in Table 30. The specimen was successfully unmolded, has shown in Figure 36, and the mechanical results are presented in Table 31.

Figure 36 – Marble residue specimen (after unmolding)

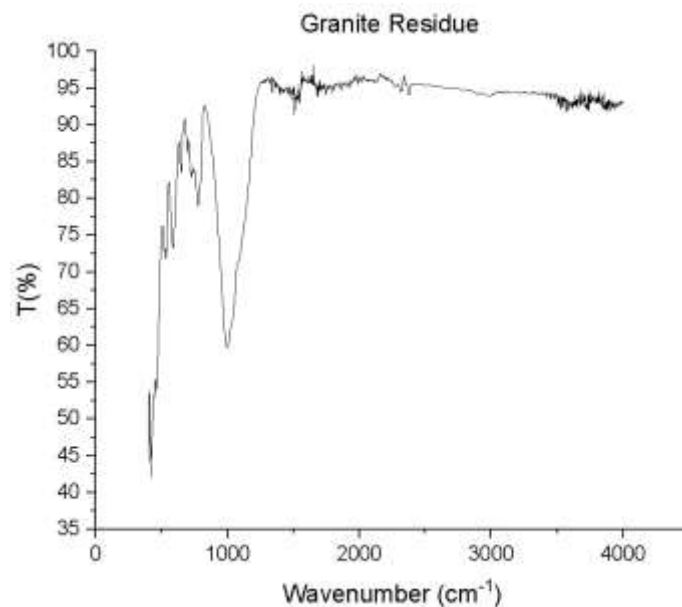
Figure 40 presents the results of the FTIR analysis using a Shimadzu IRAffinity-1S equipment with wave range between 400 and 4000 cm^{-1} , resolution of 4 and 64 scans.

Figure 40 – FTIR analysis

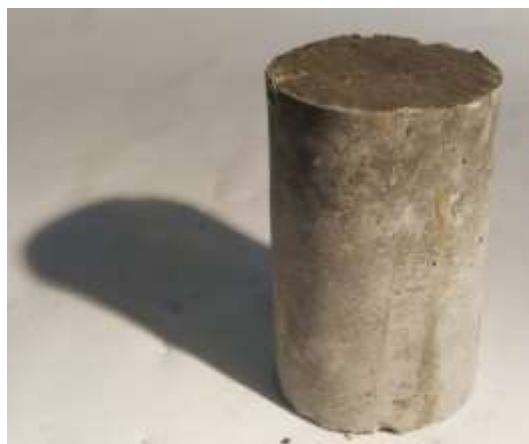
A single cylindrical specimen was produced to assess the mechanical resistance of the material. The quantity of material used for the paste is presented in Table 34. The activator used was hydroxide with a molar concentration of 5. The curing process of the paste is presented in Table 35. The specimen was successfully unmolded, has shown in Figure 41, and the mechanical results are presented in Table 36.

Figure 41 – Granite residue specimen (after unmolding)
