Accelerated climate aging tests of structural insulated panels with waste-based core materials

Roberta Moschetti, Lars Gullbrekken and Joana Maia

SINTEF Community, 7465 Trondheim, Norway

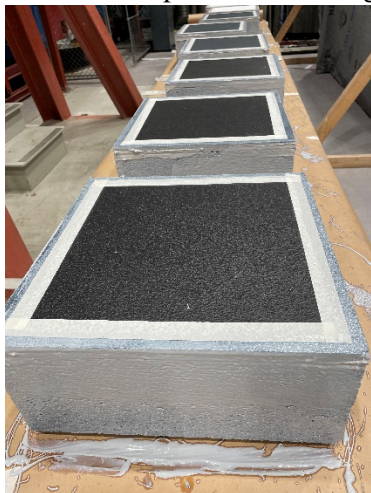
All the samples before testing

Figure 2 Pictures of the different samples before (upper left corner) and after the testing in the climate simulator.

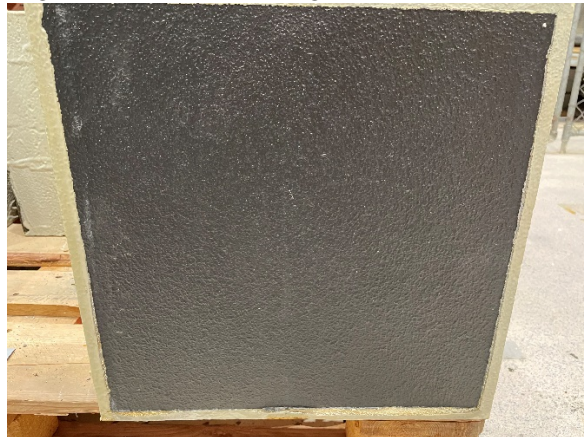
Configuration 1 end of testing

Configuration 1	Configuration 2	Configuration 3
Start.			02.12.22
11.11.22		09.12.22	Visible cracks in the front face
		Visible cracks in the front face	observed in all the samples
		observed in all the samples	
End	No cracks or delamination	Delamination observed in areas	Delamination observed in
11.12.22	observed	close to the cracks	areas close to the cracks

Visual control of the samples during and after the test sequence indicated a higher performance of configuration 1 compared to configurations 2 and 3. Further developments will include that the samples will be subjected to other specific tests to examine relevant characteristics of the materials, such as water permeability, adhesion, hard body impact, color and solar reflectance. The results will be compared to comparable tests performed before the aging test.

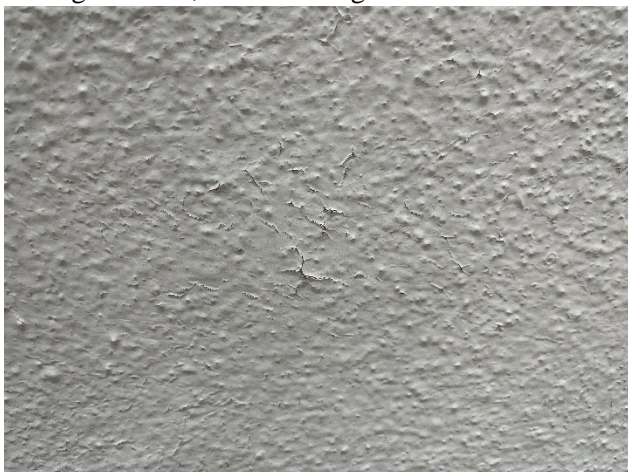
Configuration 3, end of testing
